ARC MAPPING

AN EXPLANATION AND EXAMPLE

Jason Karasinski, NYS CFI/ Wallington Engine Co. Fire Investigator Sodus, NY, Dixon Robin, Special Agent/Certified Fire Investigator, Bureau of Alcohol, Tobacco, Firearms and Explosives (ATF), Rochester NY Field Office, Howard "Bud" DeMatties, Forensic Electrical Engineer, Forensic & Failure Analysis Inc., Syracuse, NY, Gary Hauf, Forensic Electrical Engineer, Forensic & Failure Analysis Inc., Syracuse, NY

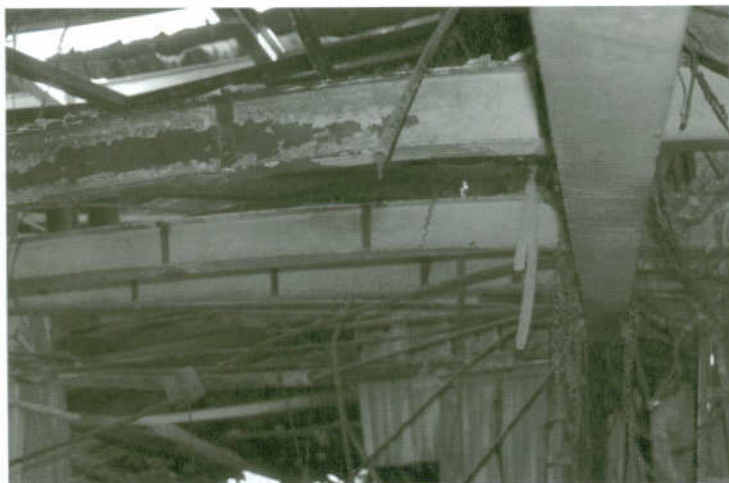
Example of Arc Mapping inside industrial fire scene

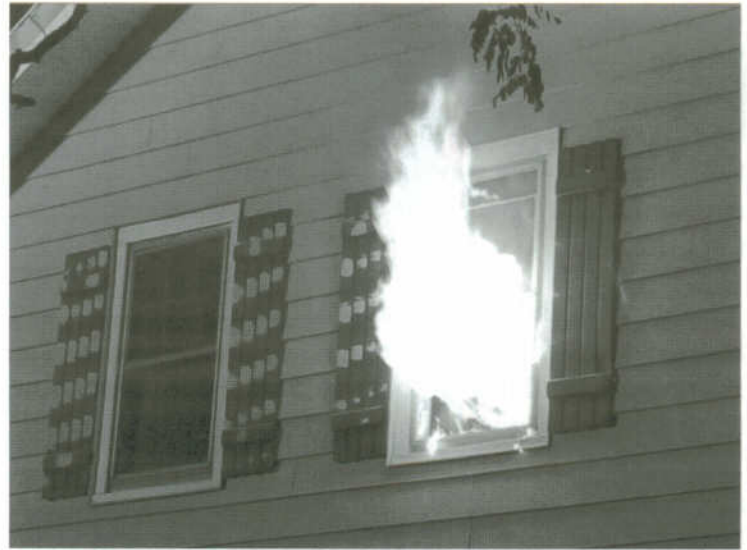
Fire damage to exterior of test structure

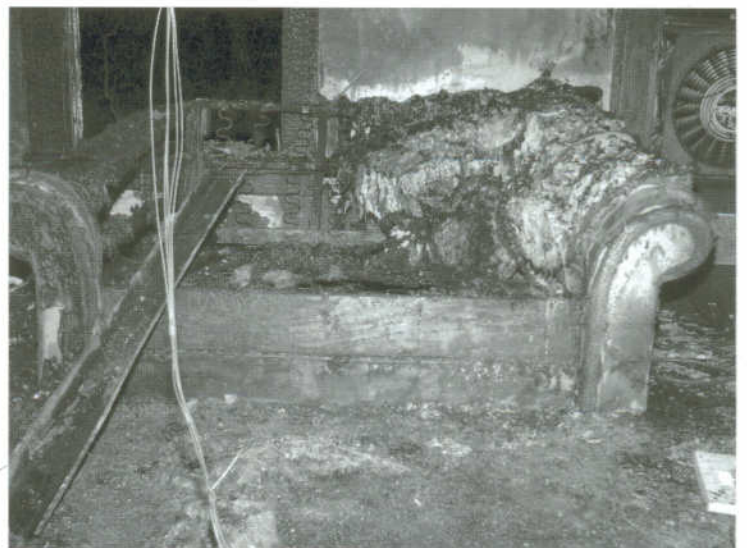
Fire damage to love seat

The furniture in the room was also heavily damaged. The loveseat along the west wall, underneath which the extension cord ran, suffered destruction of its cushioning and deep charring on its wooden frame. This damage was greater on the south side of the couch adjacent to the area of origin. The chair suffered fabric destruction on its upper surfaces; the damage lessening the further from the southwest corner where it was located. Other items such as the radio and infant car seat were destroyed by the fire. Plastic containers further away from the west wall exhibited much more survivability. This damage would have allowed most investigators to narrow their focus to the southwest quadrant of the room. In this type of scenario, the arc mapping would serve to further validate an area of origin hypothesis. By validating this area as the possible quadrant of origin, investigators can possibly eliminate numerous other ignition sources located within the fire room.

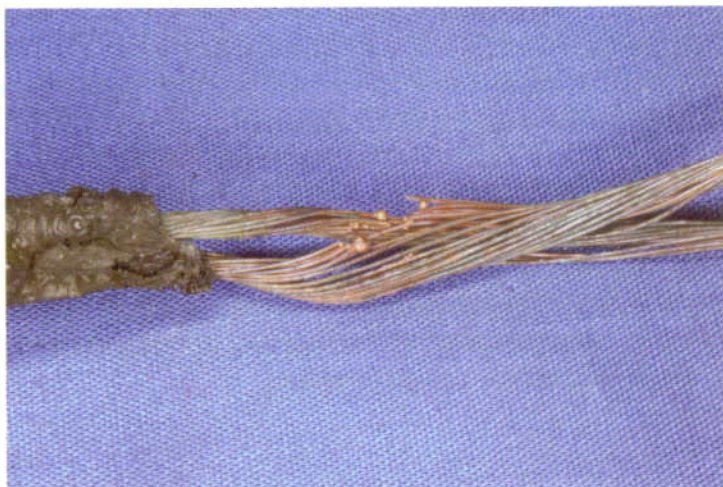
The electrical evidence removed from the scene, contained the extension cord which was heavily damaged by the fire. Much of the insulation had been destroyed, particularly in the area to the south of the couch where it lay exposed, and it took careful processing to dig out the extension cord from the scene. An examination of the extension cord revealed an arc approximately 58" from the plug head and wall outlet, corroborating the fire area of origin

Arc evidence located on zip cord

It should be noted that because of the relatively light load on the extension cord, the arc damage was relatively small. Though small, this damage was identifiable both at the scene and the laboratory. A recommendation for investigators is to stock your processing kit with a magnifying glass to assist in examining potential arc evidence.
