ARC MAPPING

AN EXPLANATION AND EXAMPLE

Jason Karasinski, NYS CFI/ Wallington Engine Co. Fire Investigator Sodus, NY, Dixon Robin, Special Agent/Certified Fire Investigator, Bureau of Alcohol, Tobacco, Firearms and Explosives (ATF), Rochester NY Field Office, Howard "Bud" DeMatties, Forensic Electrical Engineer, Forensic & Failure Analysis Inc., Syracuse, NY, Gary Hauf, Forensic Electrical Engineer, Forensic & Failure Analysis Inc., Syracuse, NY

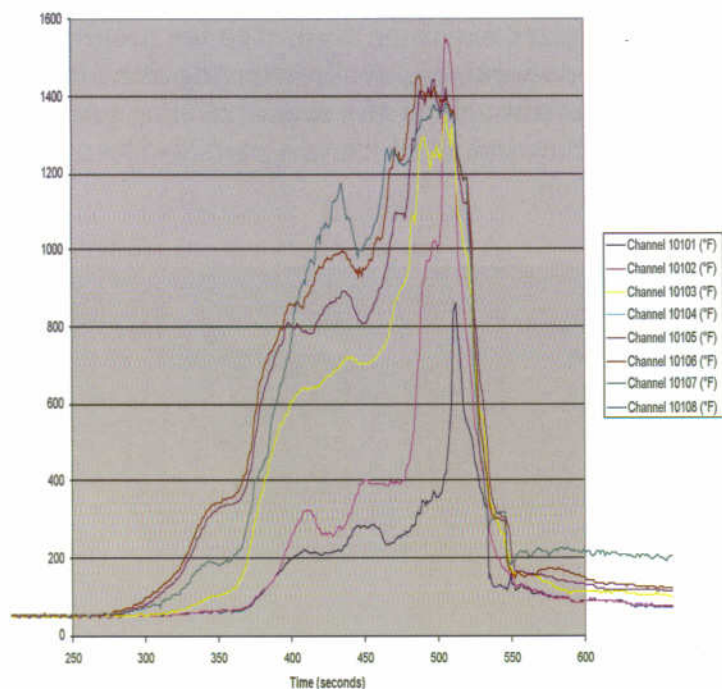
the highest temperature readings for the ceiling, approximately 363 Fahrenheit at floor level and 1443 Fahrenheit just below ceiling level. At this juncture, the couch and other fuel packages were involved in fire. During the fire event, the door to the room was manipulated to ensure the fire had enough ventilation to grow.

Shortly thereafter (approximately 15 seconds later), floor temperatures reached a maximum of 861 Fahrenheit, doubling in that short span). At this point the ceiling temperature had started to fall and recorded 1338 Fahrenheit. The video feed, though intact, was not providing much value at this point as the smoke layer in the room had descended to the floor. The floor temperature reading indicates that the fire did not have the capability to cause copper wiring to melt*. Their survivability enhanced the Fire Investigators ability to make the origin determination.

Time versus Temperature graph recording fire event. Note the dark blue line represents floor level, while the green line represents ceiling level.
